INDOOR AIR QUALITY ASSESSMENT

**J.W. Martin Elementary School
9 Landry Avenue
North Attleborough, Massachusetts**

Prepared by:
Massachusetts Department of Public Health
Center for Environmental Health
Emergency Response/Indoor Air Quality Program
August 2005

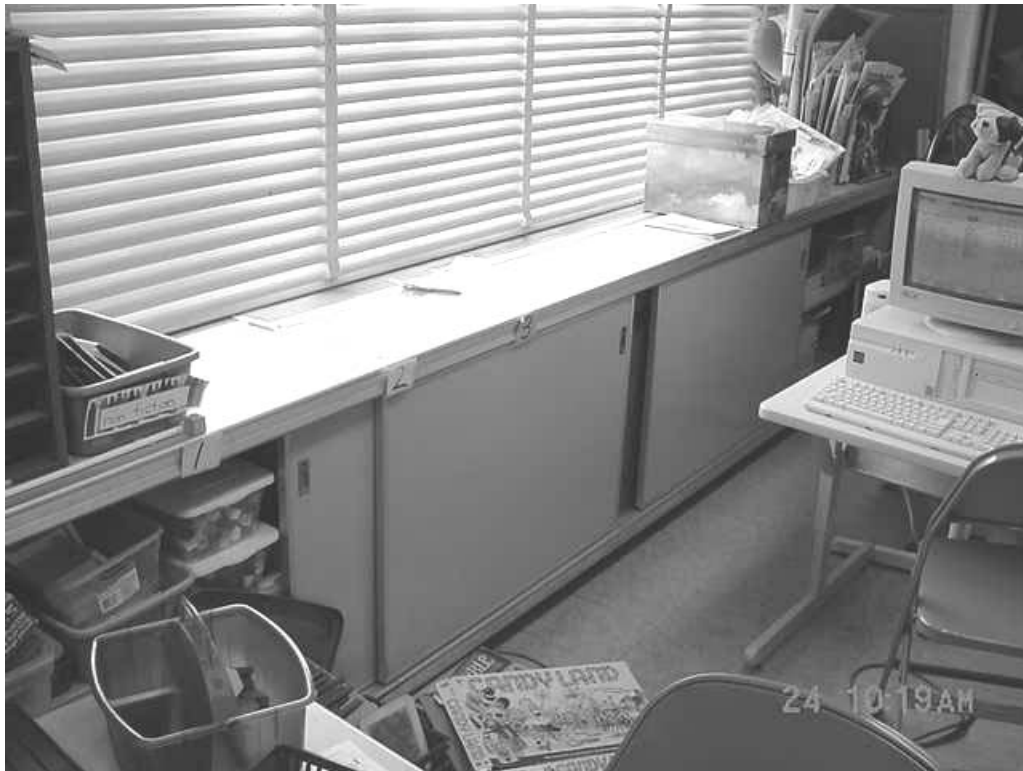
Picture 1

Classroom Univent in Cabinet, Diffuser along Windowsill

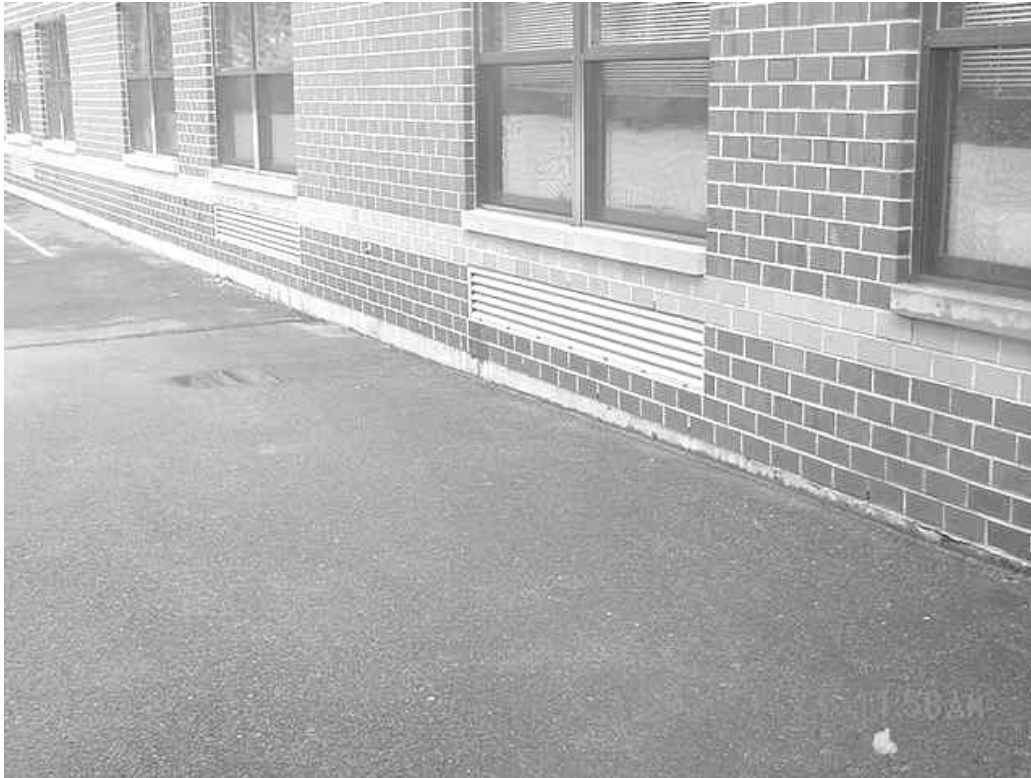
Picture 2

Univent Fresh Air Intakes

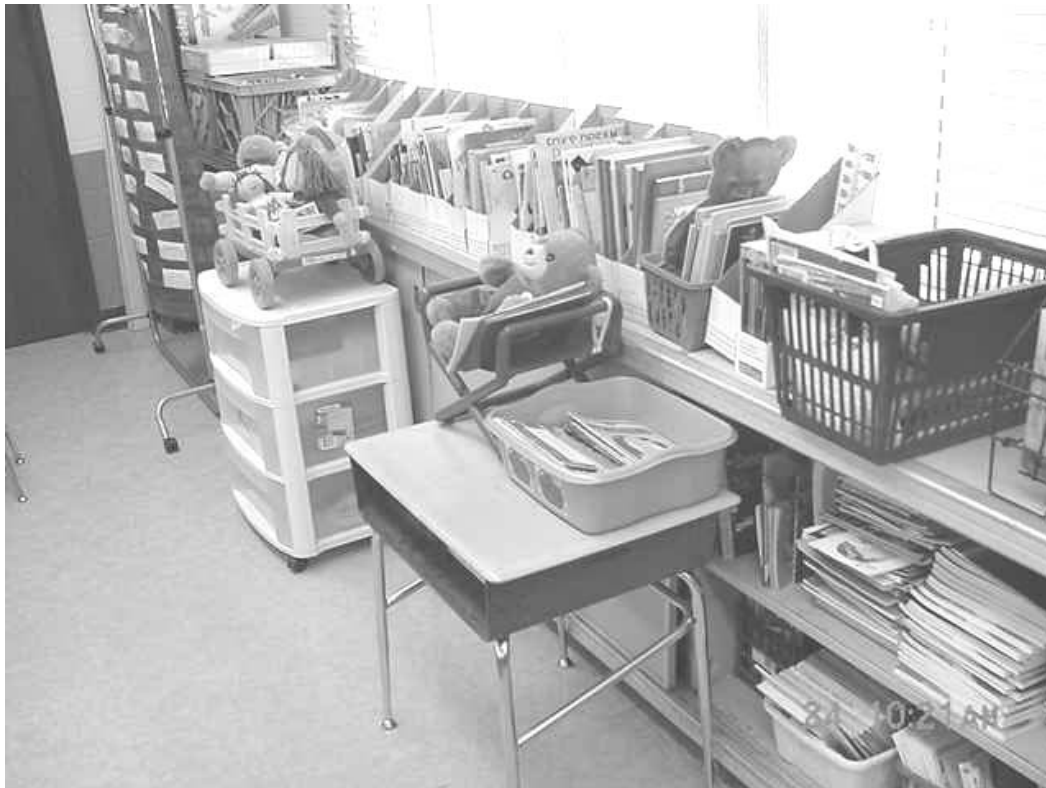
Picture 3

It can be seen from Table 1 that carbon dioxide levels were above 800 parts per million (ppm) parts of air in eighteen of forty areas surveyed, indicating inadequate air exchange in a number of areas, primarily in the 1967 portion of the building. Fresh air in classrooms is supplied by a unit ventilator (univent) system (Picture 1). Univents are designed to draw air from outdoors through a fresh air intake located on the exterior walls of the building (Picture 2) and return air through an air intake located at the base of each unit ([Figure 1](#)). Fresh and return air are mixed and filtered, then heated and provided to classrooms through an air diffuser located in the top of the unit. Univents did not appear to run continuously but rather were activated by thermostats. Univents are activated once room temperatures drop below a set level. When the room temperature exceeds the thermostat setting, univents deactivate. Therefore, no mechanical ventilation is provided until the thermostat re-activates the system. Obstructions to airflow, such as papers and books stored on univents and bookcases, carts and desks in front of univent returns, were seen in several

classrooms. In order for univents to provide fresh air as designed, units must remain free of obstructions.

Classroom Univent Obstructe4d by Various Items

4. Inspect exhaust motors and belts for proper function. Repair and replace as necessary.
5. Remove all blockages from univents and exhaust vents to ensure adequate airflow.

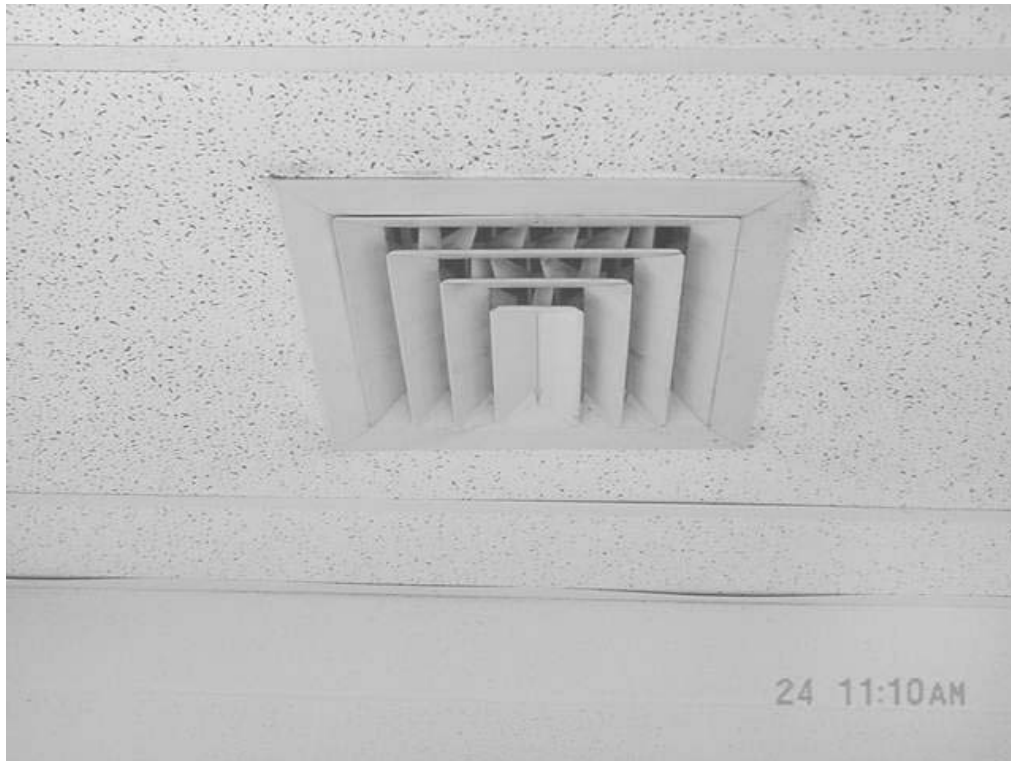
Picture 4

Ceiling-Mounted Supply Vent

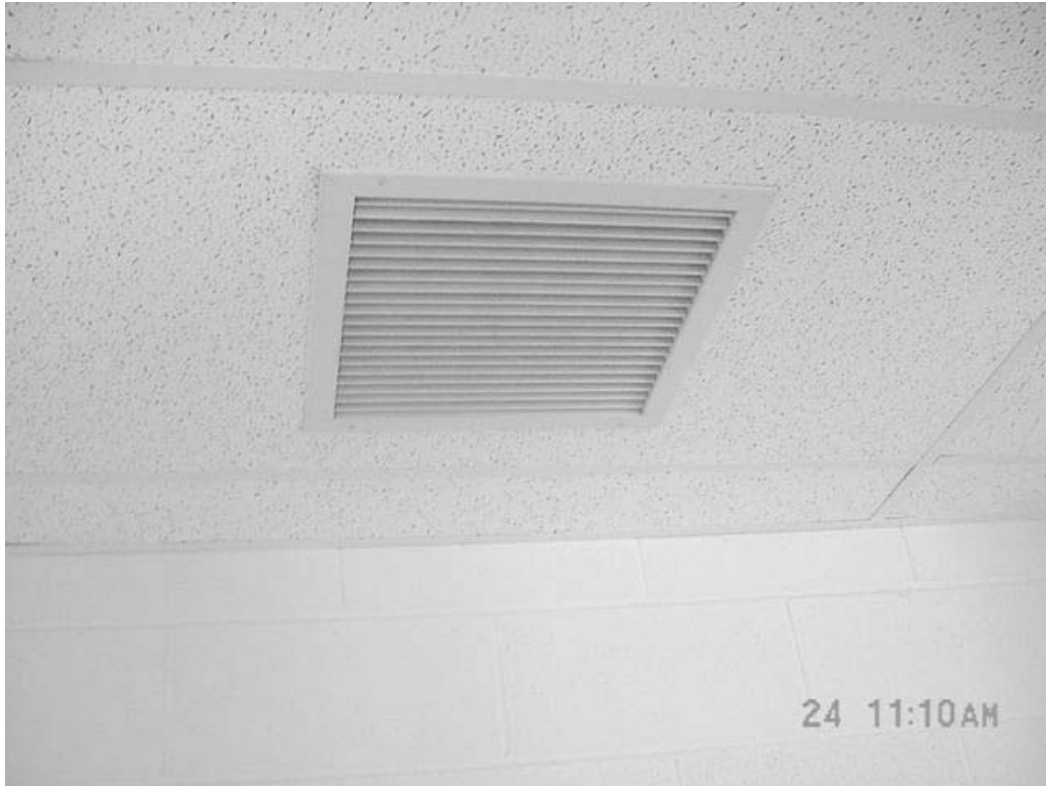
Picture 5

Ceiling-Mounted Return Vent

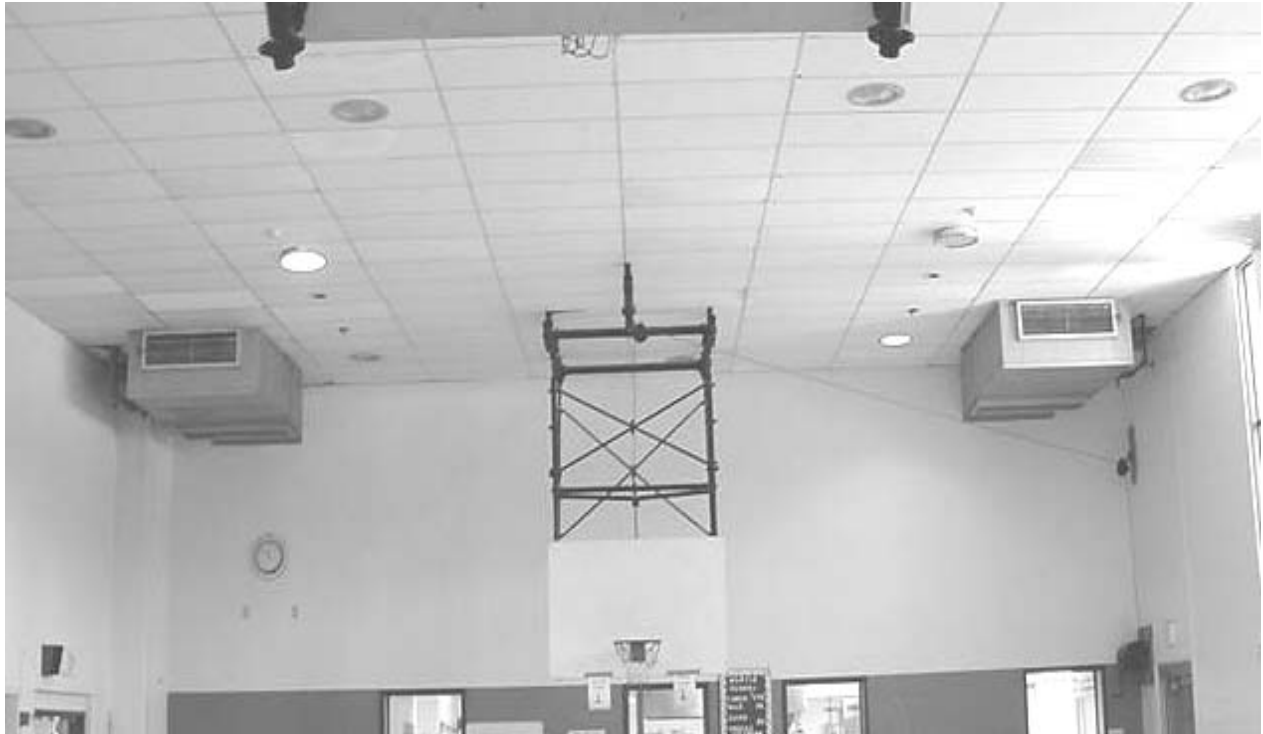
Picture 6

Mechanical ventilation for interior rooms is provided by rooftop air handling units (AHUs). Fresh air is distributed to the classroom via ductwork connected to ceiling-mounted air diffusers. Return vents draw air back to the AHUs through wall or ceiling-mounted grilles (Pictures 4 and 5). The cafeteria is designed to be ventilated by two ceiling-mounted AHUs (Picture 6) that were not operating during the assessment.

Ceiling-Mounted AHUs in Cafeteria

3. Operate all ventilation systems that are operable throughout the building (e.g., cafeteria, classrooms) *continuously* during periods of school occupancy and independent of thermostat control. To increase airflow in classrooms, set univent controls to “high”.

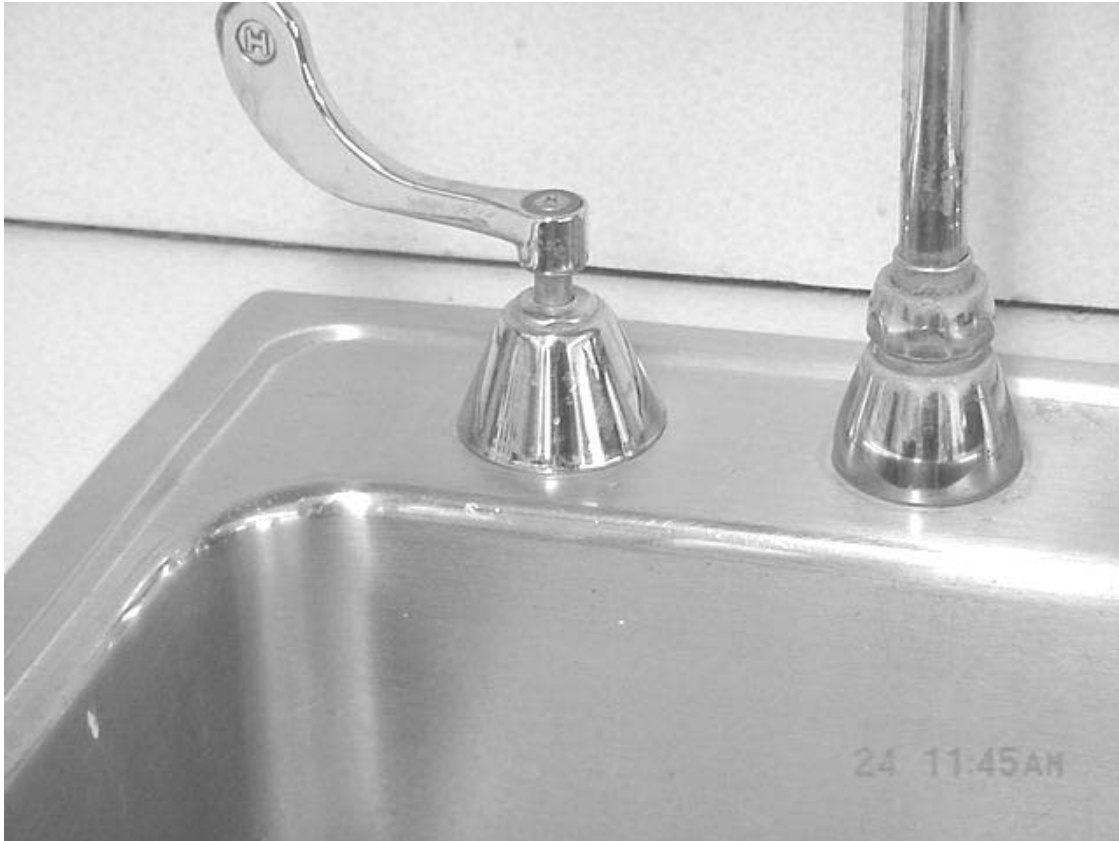
Picture 7

Spaces between the sink countertop and backsplash were seen in several classrooms (Table 1/Picture 7). Improper drainage or sink overflow can lead to water penetration of countertop wood, the cabinet interior and behind cabinets. Like other porous materials, if these materials become wet repeatedly they can provide a medium for mold growth.

Spaces between Sink Countertop and Backsplash

12. Seal areas around sinks to prevent water-damage to the interior of cabinets and adjacent wallboard. Inspect wallboard for water damage and mold growth, repair/replace as necessary. Disinfect areas with an appropriate antimicrobial, as needed.

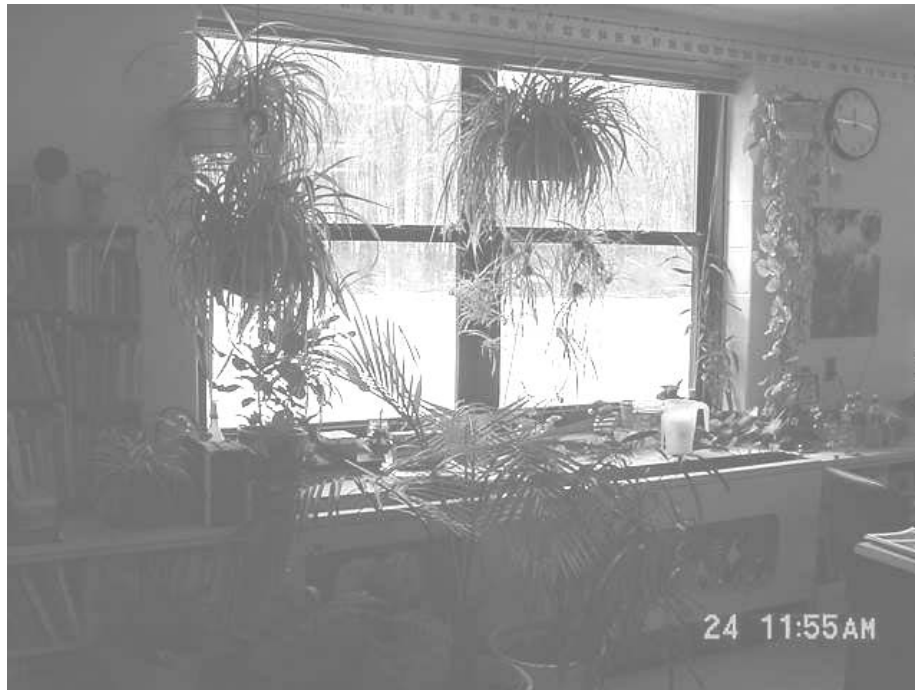
Picture 8

Plants were noted in several classrooms. Plants can be a source of pollen and mold, which can be respiratory irritants for some individuals. Plants should be properly maintained and equipped with drip pans. Plants should also be located away from univents to prevent the aerosolization of dirt, pollen or mold (Picture 8).

Plants Hanging over Classroom Univent

9. Move plants away from univents in classrooms. Avoid over-watering and examine drip pans periodically for mold growth. Disinfect with an appropriate antimicrobial where necessary.

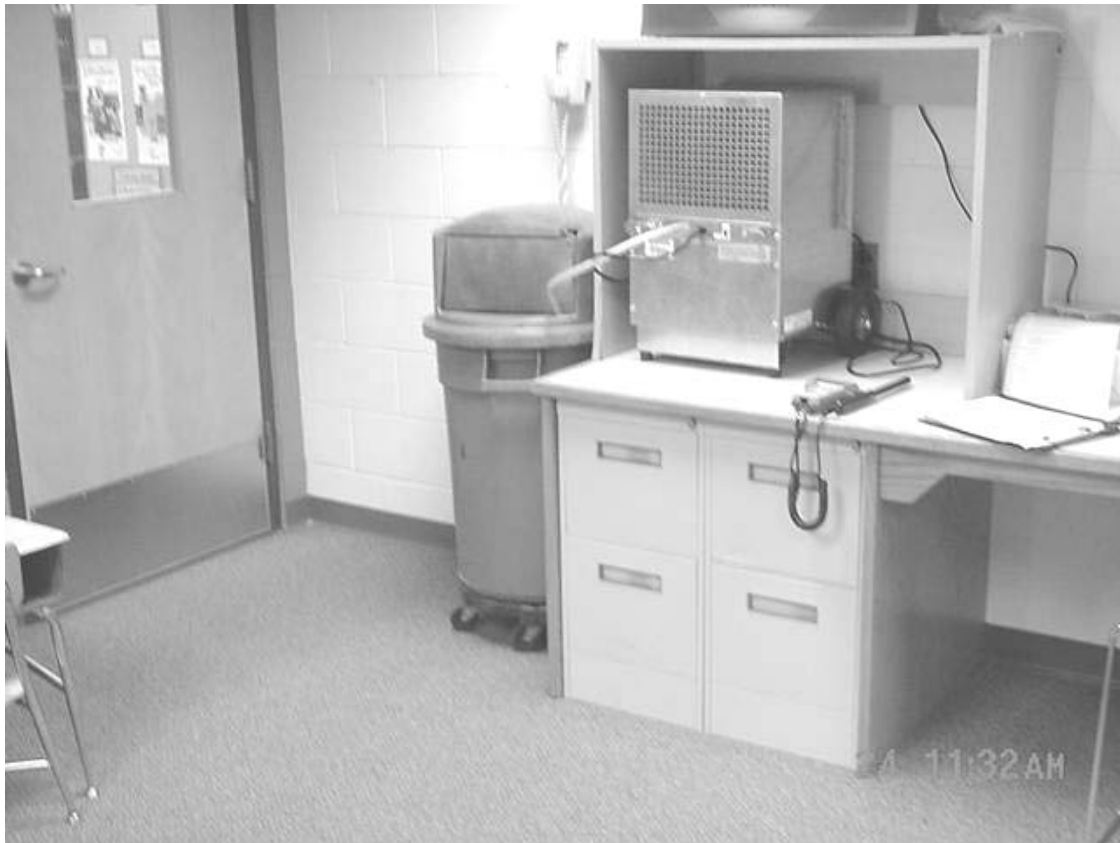
Picture 9

During the assessment a dehumidifier was observed in the computer lab draining into a trash barrel (Picture 9). A musty odor was detected from the barrel. The source appeared to be wet rags in standing water at the bottom of the barrel (Picture 10). As discussed wet porous materials can provide a medium for mold growth and associated odors.

Dehumidifier Emptying into Trash Barrel

10. Contact a masonry firm or general contractor to repair holes/breaches in exterior walls to prevent water penetration, drafts and pest entry.
11. Empty barrel used to drain dehumidifier regularly to prevent standing water, mold growth and associated odors. Clean and disinfect with an appropriate anti-microbial as needed.

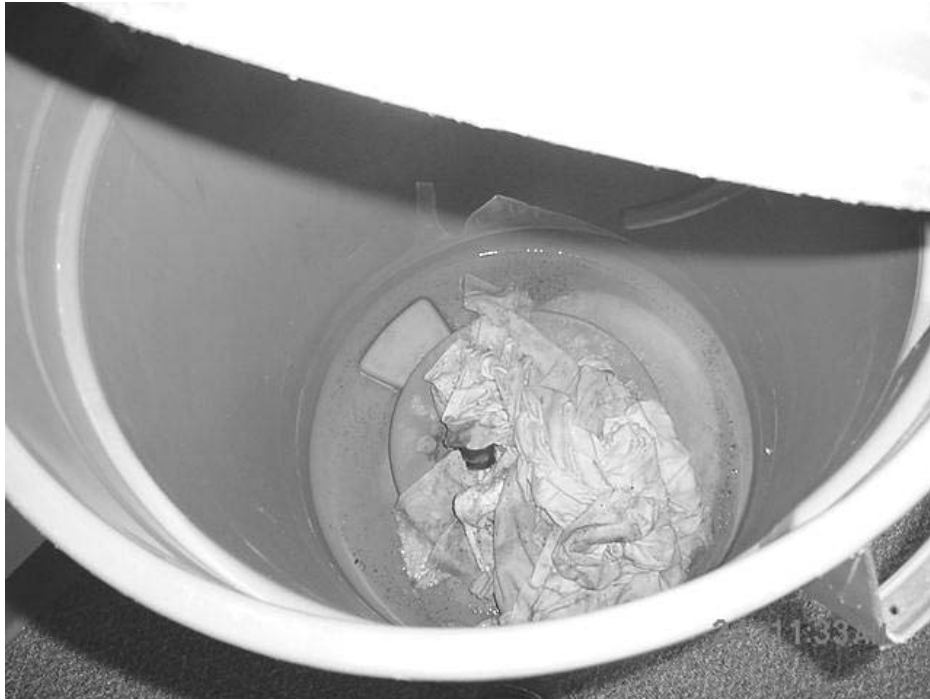
Picture 10

Wet Rags and Standing Water in Bottom of Barrel in Preceding Picture

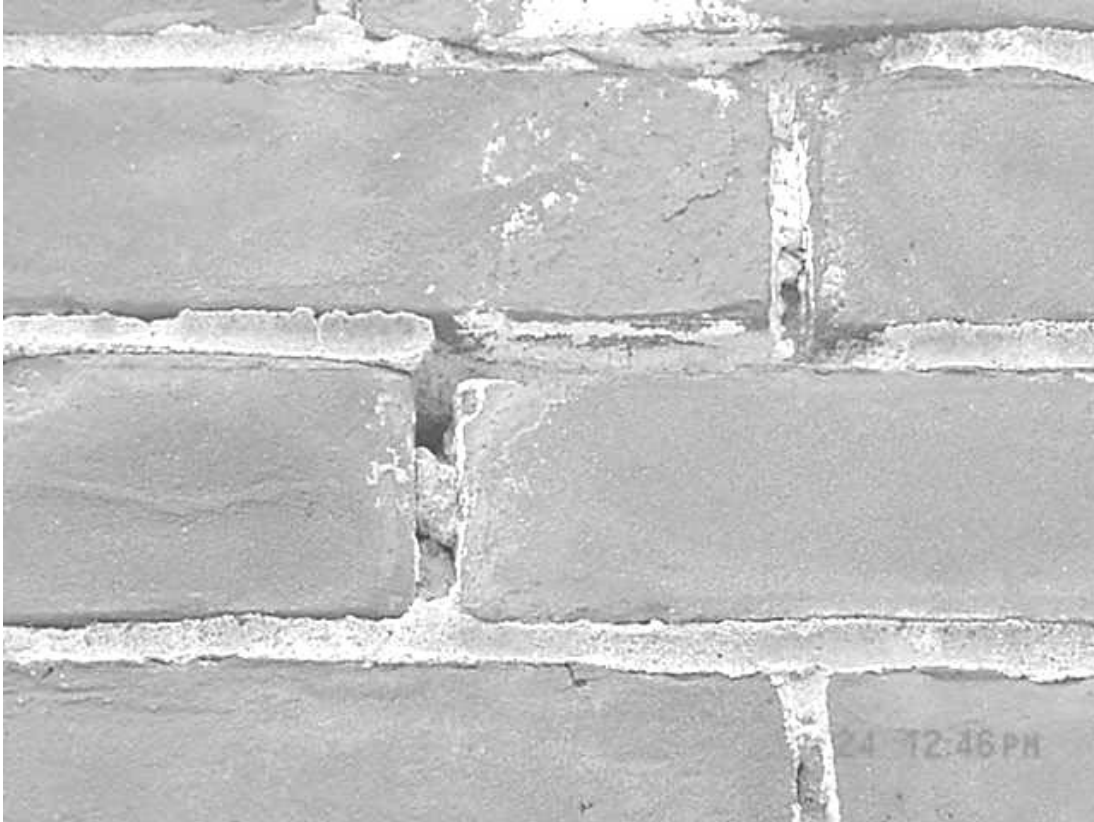
Picture 11

Several areas were observed on the exterior of the building where mortar around brick was missing and/or damaged (Pictures 11 and 12). Repeated water penetration can result in the chronic wetting of building materials and potentially lead to microbial growth. In addition, cracks/holes in exterior walls may provide a means of egress for pests/rodents into the building.

Missing/Damaged Mortar around Exterior Brick

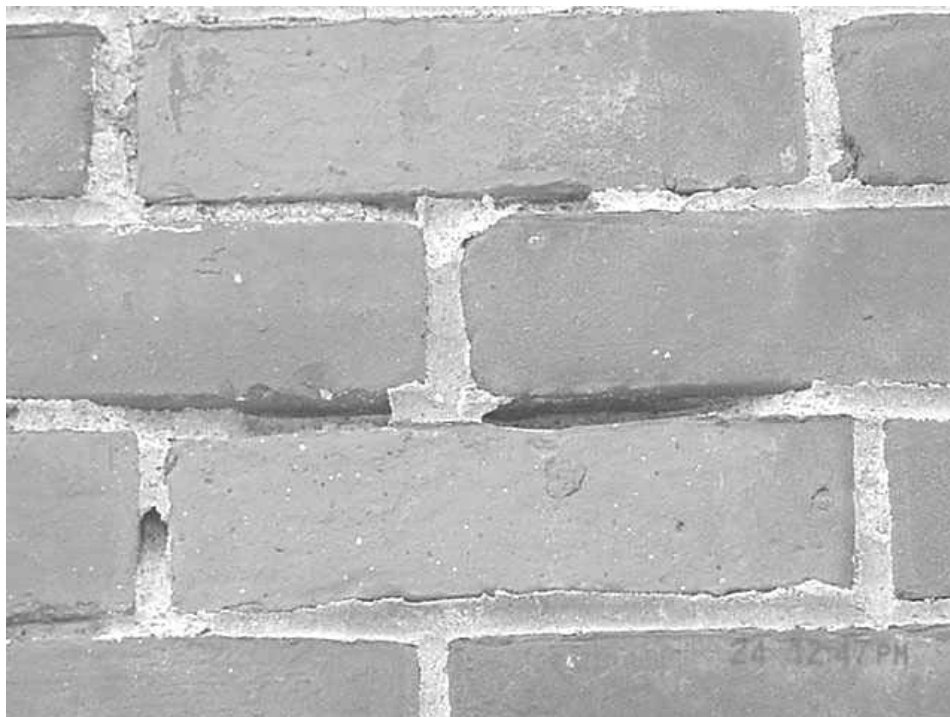
Picture 12

Missing/Damaged Mortar around Exterior Brick

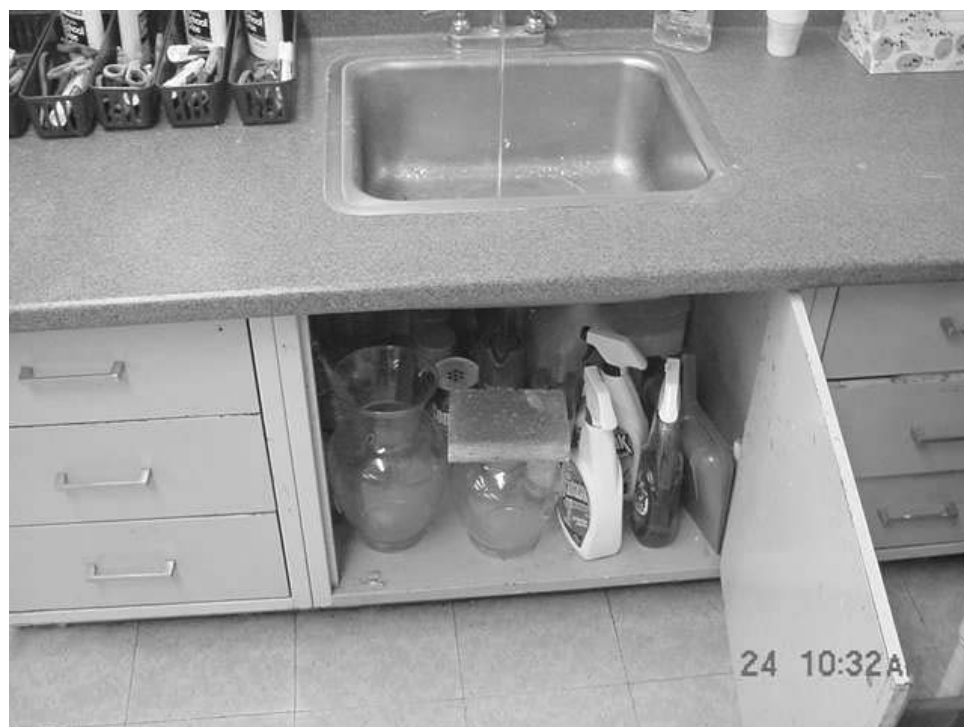
Picture 13

Please note, that the TVOC air measurements are only reflective of the indoor air concentrations present at the time of sampling. Indoor air concentrations can be greatly impacted by the use of TVOC containing products. While no measure able TVOC levels were detected in the indoor environment, VOC-containing materials were noted. Several classrooms contained dry erase boards and dry erase markers. Materials such as dry erase markers and dry erase board cleaners may contain volatile organic compounds (VOCs), (e.g., methyl isobutyl ketone, n-butyl acetate and butyl-cellusolve) (Sanford, 1999), which can be irritating to the eyes, nose and throat. Cleaning products were found on countertops and beneath sinks in a number of classrooms (Picture 13). Cleaning products contain VOCs and other chemicals, which can be irritating to the eyes, nose and throat and should be stored properly and kept out of reach of students.

Spray Cleaning Products under Sink in Classroom

15. Store cleaning products properly and out of reach of students.
16. Consider discontinuing the use of tennis balls on chairs to prevent latex dust generation.

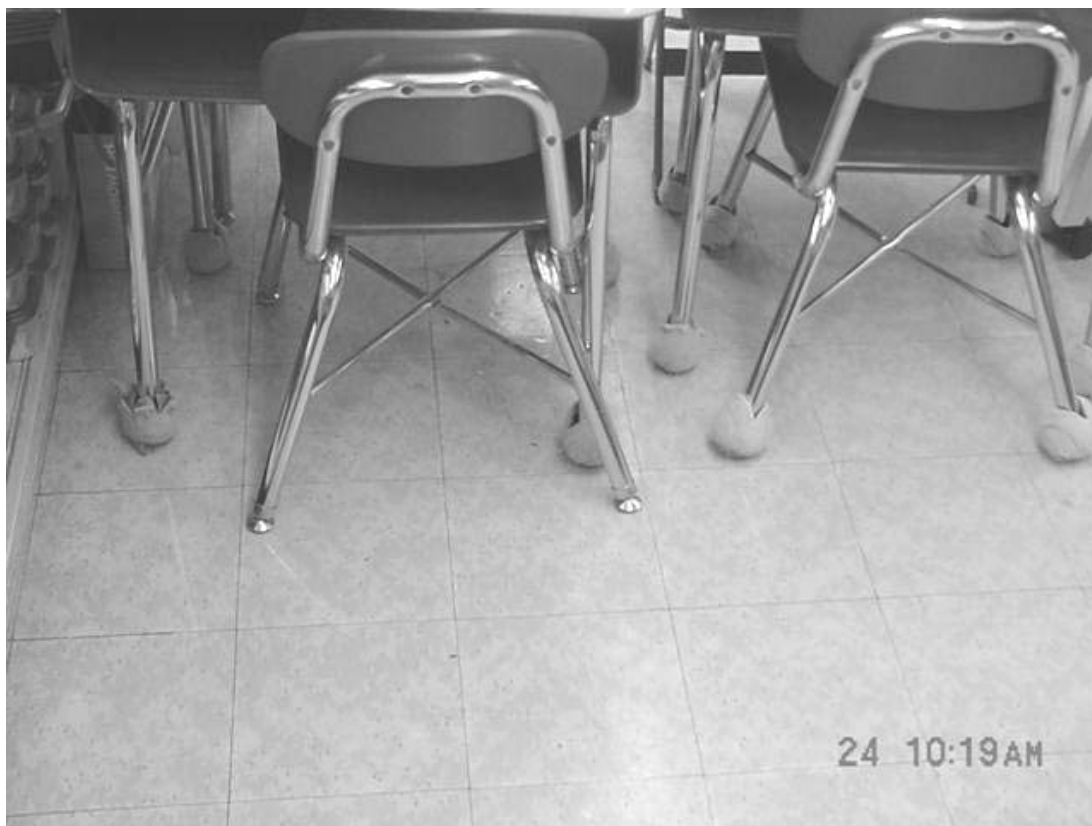
Picture 14

Finally, in an effort to reduce noise from sliding chairs, tennis balls had been sliced open and placed on chair legs (Picture 14). Tennis balls are made of a number of materials that are a source of respiratory irritants. Constant wearing of tennis balls can produce fibers and off-gas TVOCs. Tennis balls are made with a natural rubber latex bladder, which becomes abraded when used as a chair leg pad. Use of tennis balls in this manner may introduce latex dust into the school environment. Some individuals are highly allergic to latex (e.g., spina bifida patients) (SBAA, 2001). It is recommended that the use of materials containing latex be limited in buildings to reduce the likelihood of symptoms in sensitive individuals (NIOSH, 1997). A question and answer sheet concerning latex allergy is attached as [Appendix B](#) (NIOSH, 1998).

Tennis Balls on Chair Legs
